# H.M.C.S. SACKVILLE (K-181)

## HULL FRAMING ASSESSEMENT

## RE: SACKVILLE INTERIOR FRAME INSPECTION & SHIPYARD SPECIFICATION

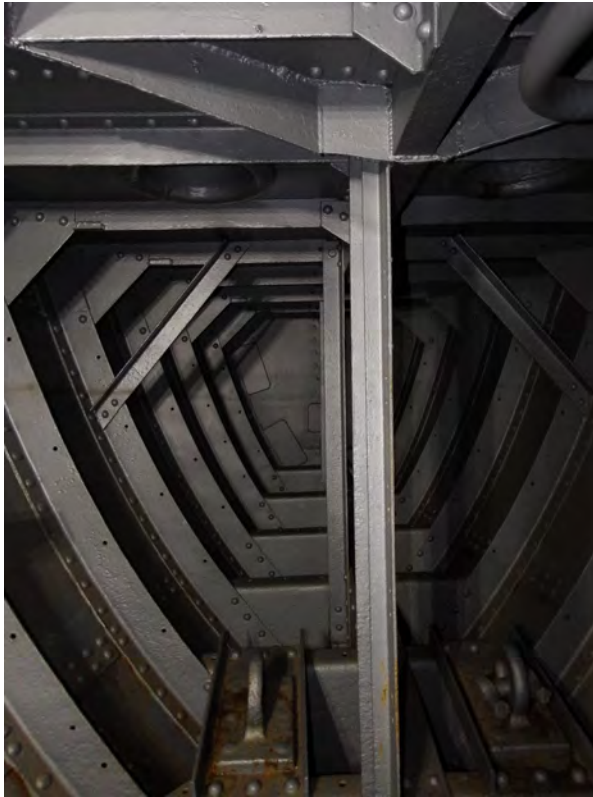
CABLE LOCKER, FR. 8-19

Frames in excellent material condition. no standing water and well painted.

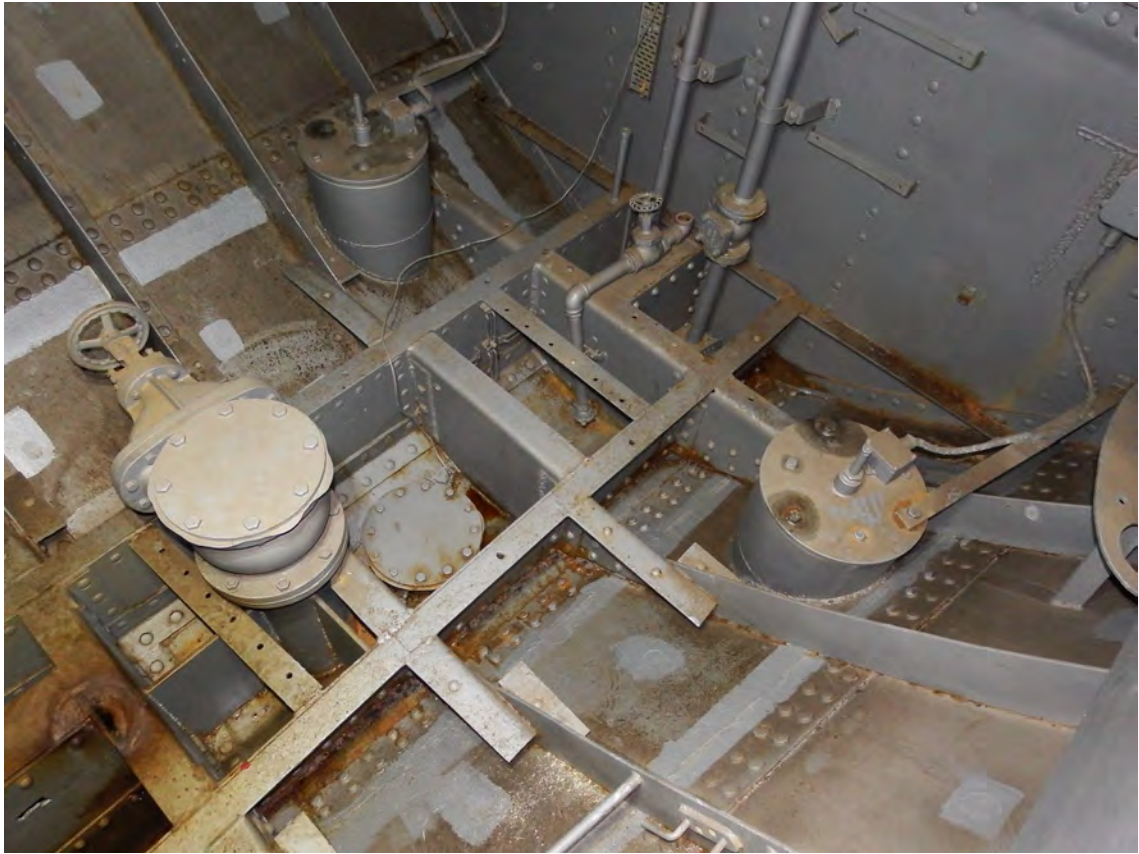
#1 STOREROOM, FR. 19 - 24

Frames in excellent material condition, mild rust/scale, no standing water and well painted.

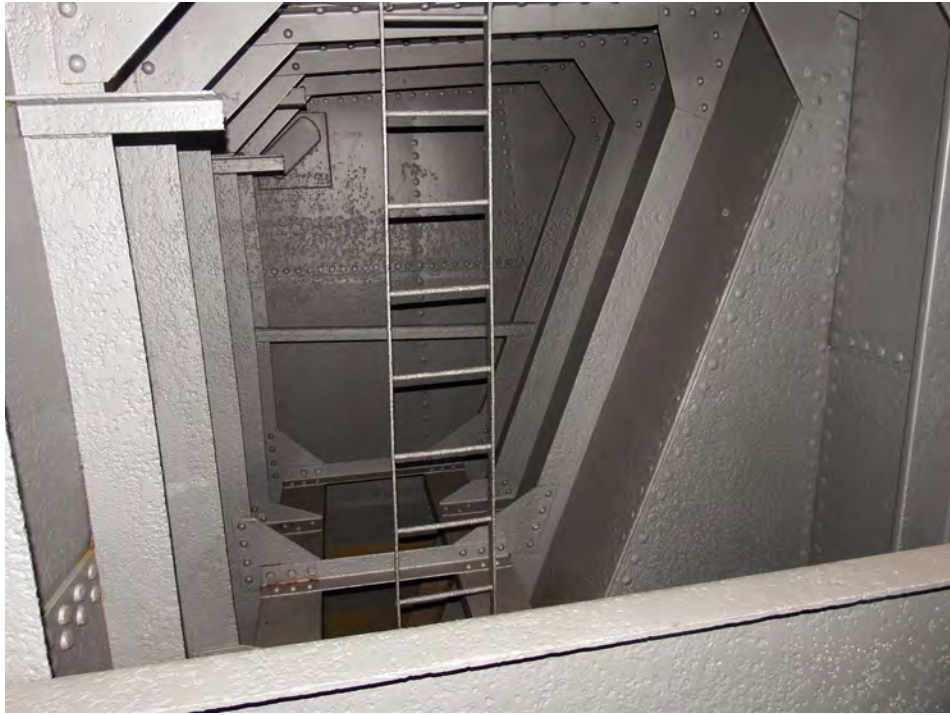
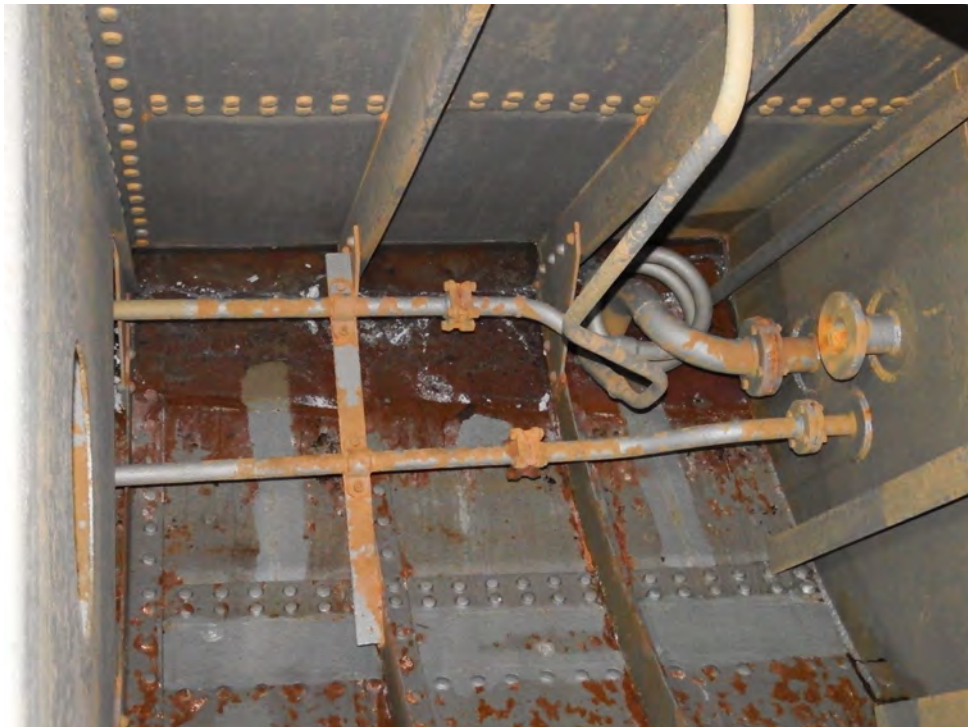
#5 & #6 BALLAST TANKS, FR. 43 – 52

Frames in excellent material condition. minimal standing water with rust/scale, well painted.

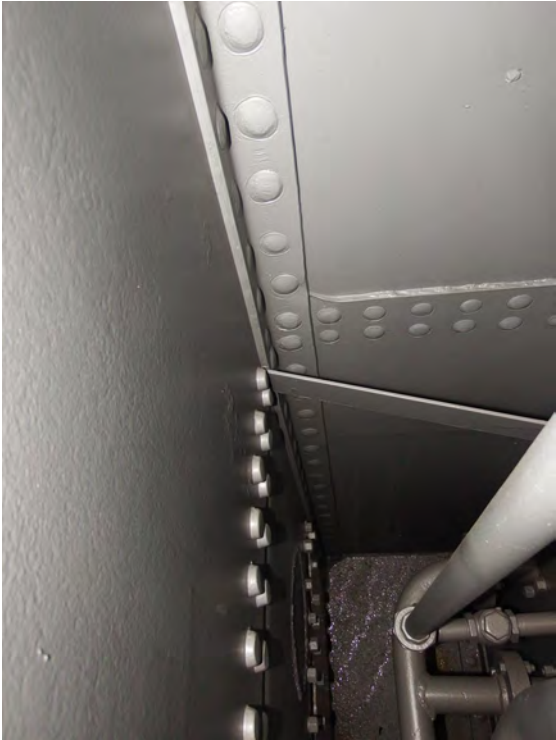
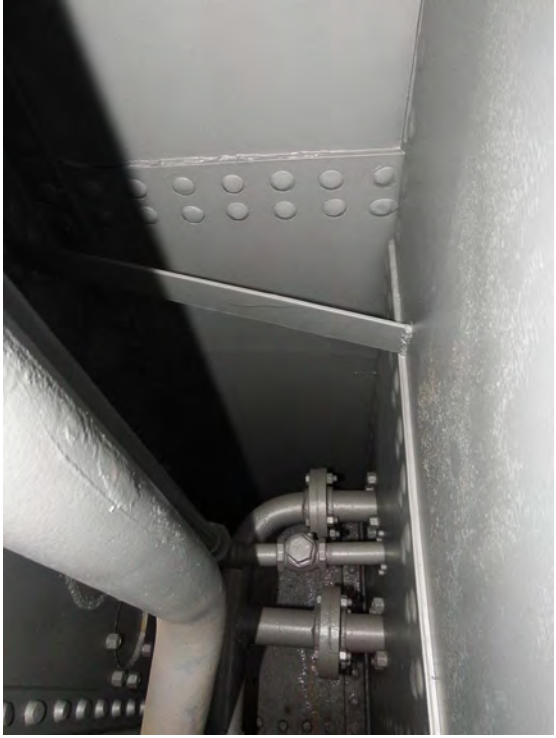
Cofferdam, FR. 54 ½ - 57

Frames in excellent material condition. no standing water and well painted.

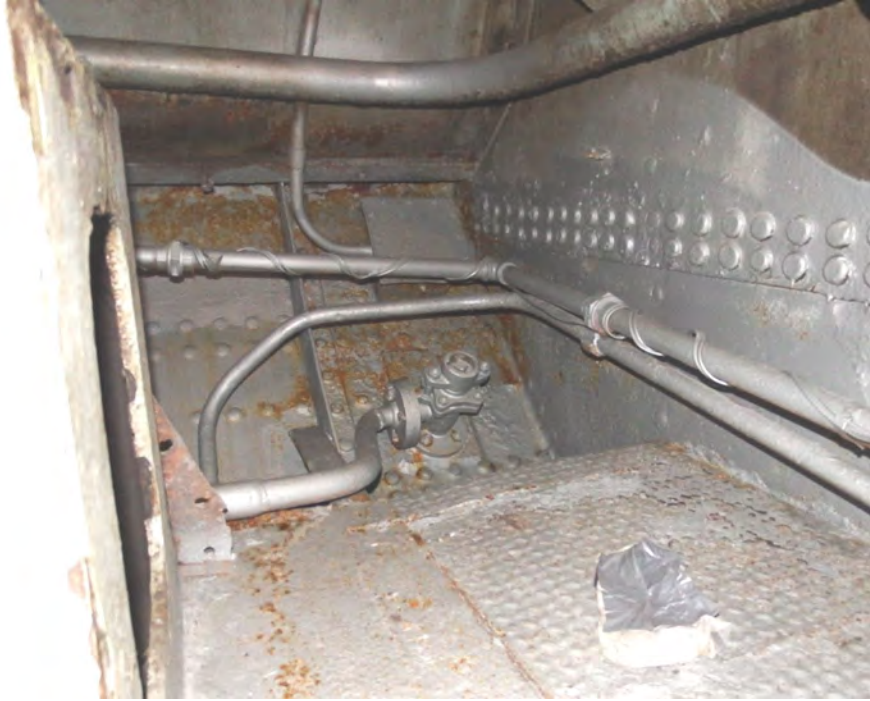
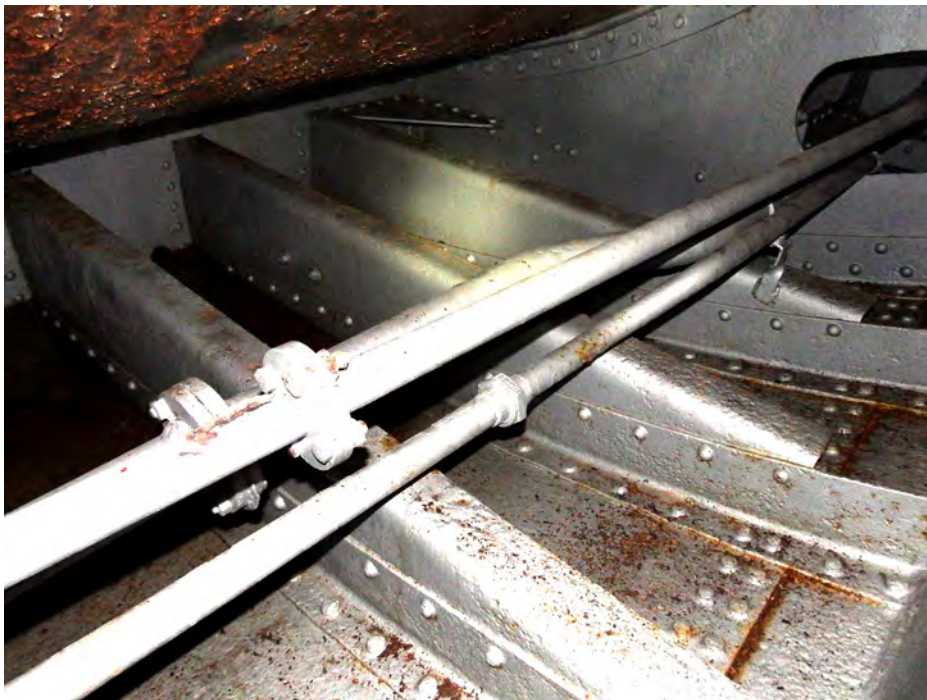
BOILER ROOM, FR. 57 - 70

Frames in excellent material condition. no standing water and well painted. Boiler foundation looks excellent.

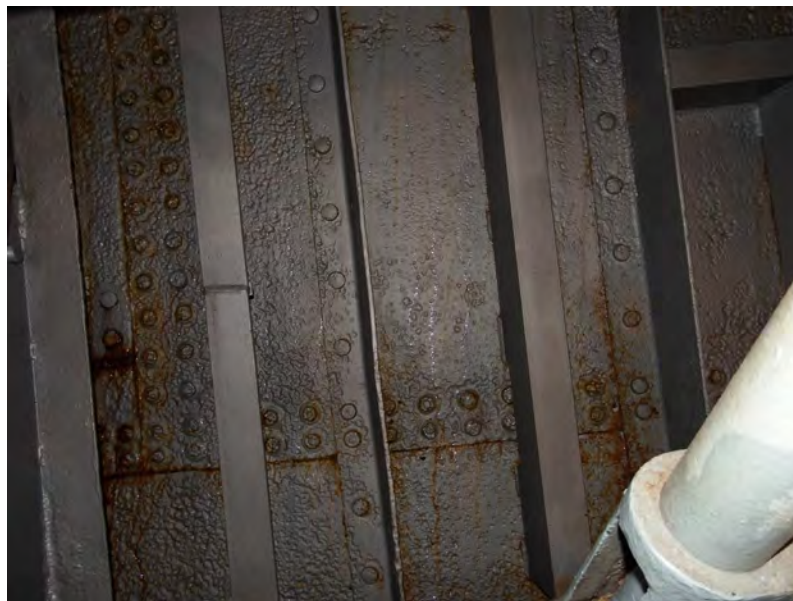
Damage/corroded frames to port and starboard repaired as needed. New sister frames inserted between originals. Space is well painted. Main engine foundation intact and in good material condition.

**New sister frames inserted between originals to port and starboard.**

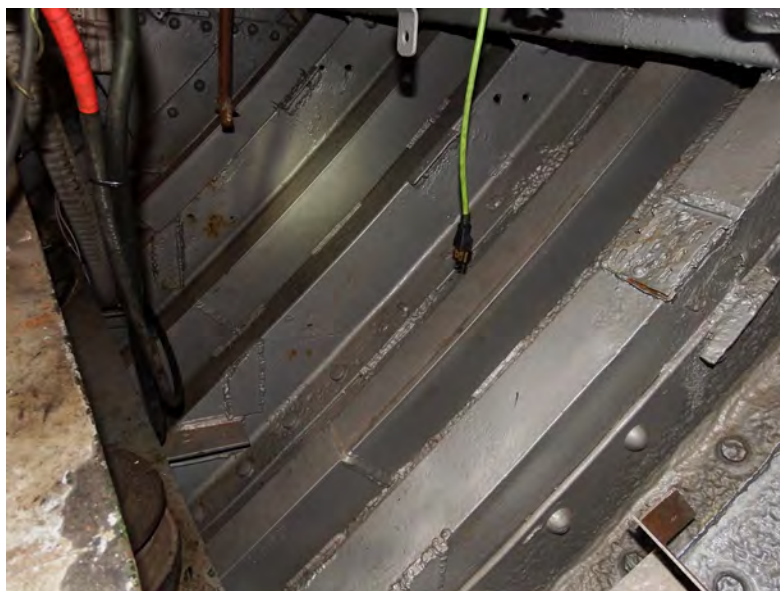
**Another view showing original and sister frames.**

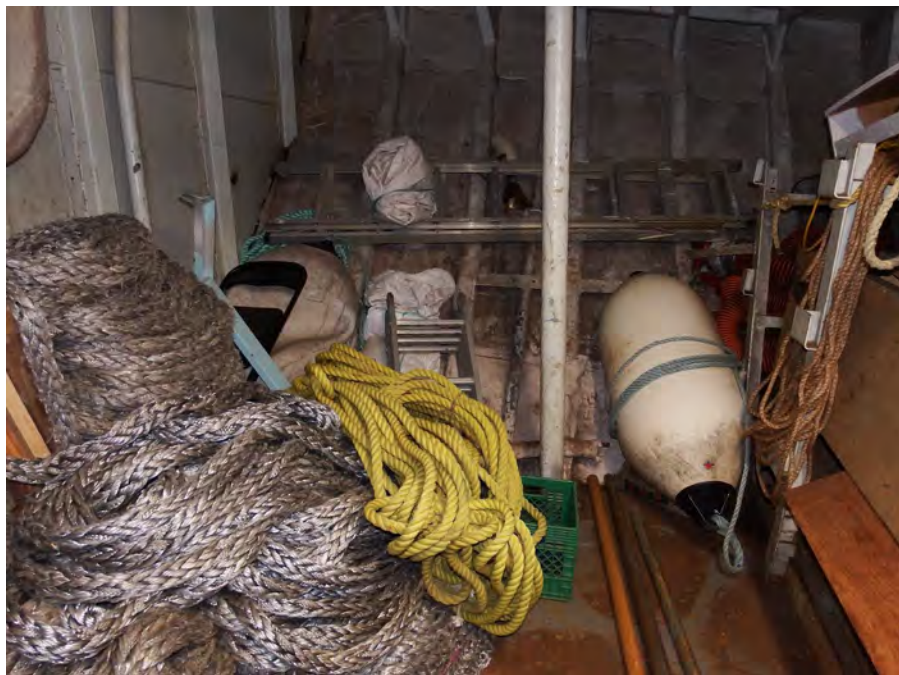
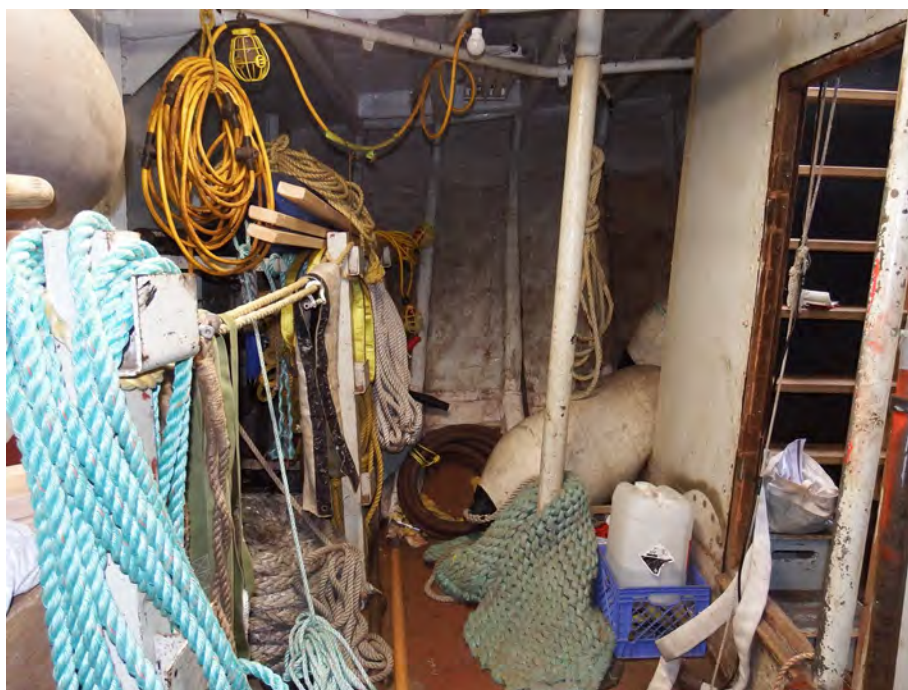
#3 STOREROOM, FR. 87 – 96

Frames in excellent material condition. no standing water and well painted.

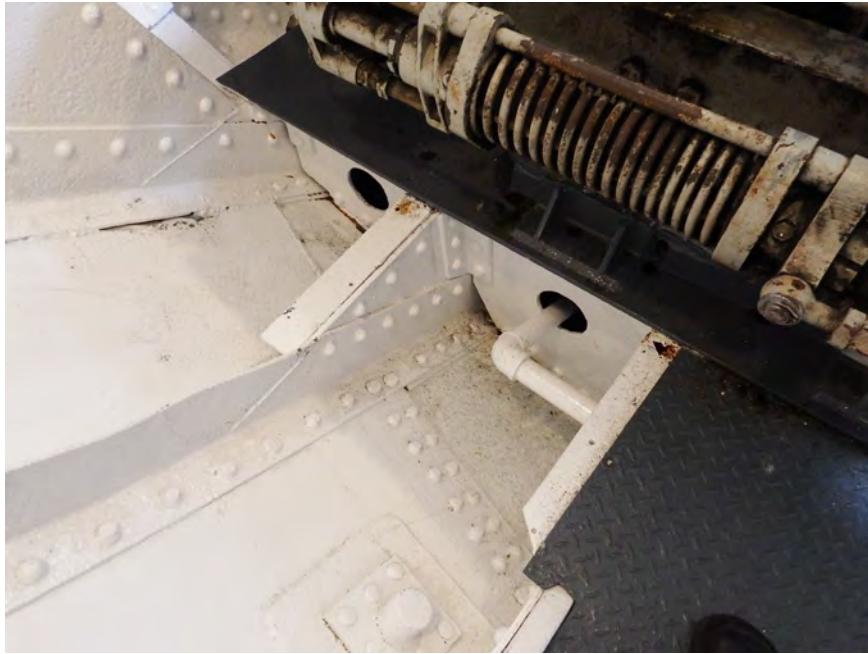
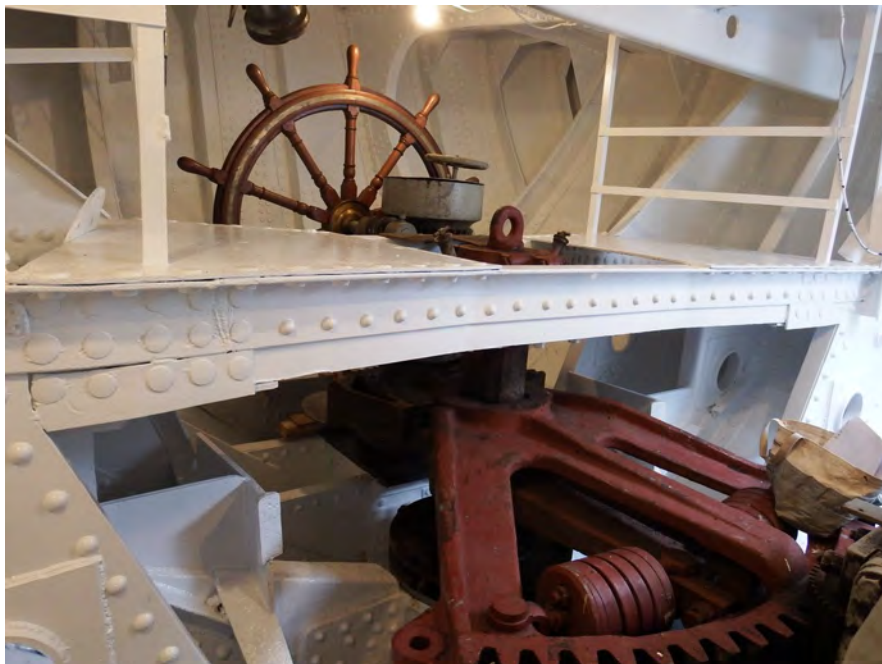
STEERING GEAR COMPARTMENT, FR. 99 – 107

In great material condition. Framing intact with good foundations for the steering engine. Well painted.
